# SLIPPERY ASPHALT RUNWAYS AFTER REJUVENATION

S Emery  
University of Witwatersrand, South Africa. [emery@iafrica.com](mailto:emery@iafrica.com)  
A Norheim  
Tribolo, Norway [armann.norheim@gmail.com](mailto:armann.norheim@gmail.com)  
I Mihaljevic  
Kamen Engineering, Australia. [kamen@kameneng.com](mailto:kamen@kameneng.com)

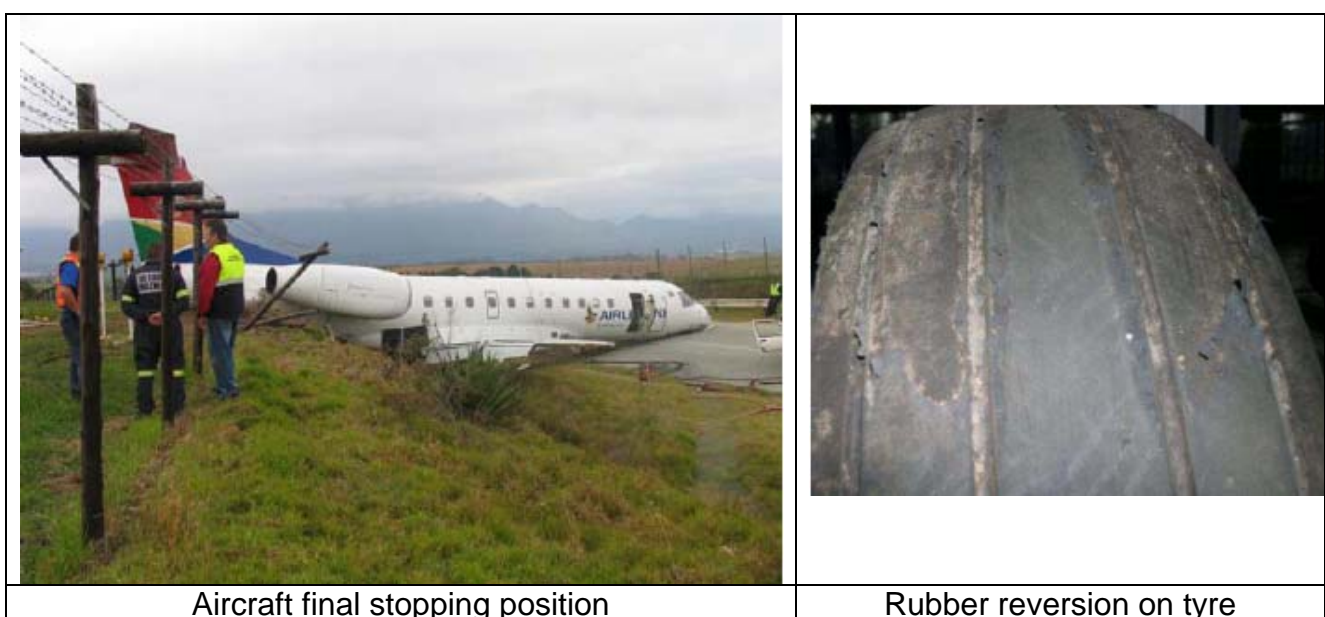
The runway length was 2000 m with an upslope of 0.4%. According to figures provided by the manufacturer, the aircraft should have been able to have come to a complete stop in a distance of 1895 m. The deceleration obtained was on average -0.1g where levels of more than -0.15g were required to stop the aircraft in the distance available. The EMB 135 aircraft (ZS-SJW) was not fitted with a thrust reverser system and is fully reliant on the braking system of the aircraft (including spoilers) to bring the aircraft to a stop. All indications are that the aircraft was serviceable and that the anti-skid braking system of the aircraft worked as it should have, but that due to the slippery surface, the system was unable to apply sufficient brake pressure to effectively stop the aircraft. Although pilots may be applying maximum braking, the system will limit the actual brake pressure to prevent the wheels from locking. The tyres did display some evidence of aquaplaning, as there was a partial scalding effect to the tread rubber and the surface of the tread rubber had some evidence of reversion and peeling of the compound (Figure 1).

Figure 1 – George accident

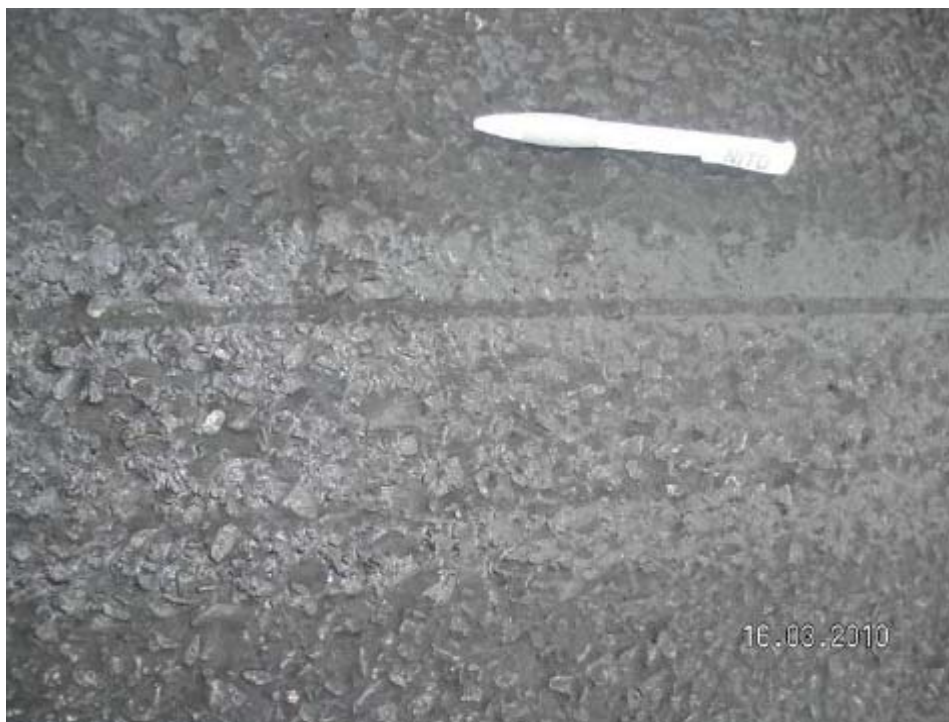
Figure 2 - Shiny wheeltrack, covered aggregate and filled-up voids

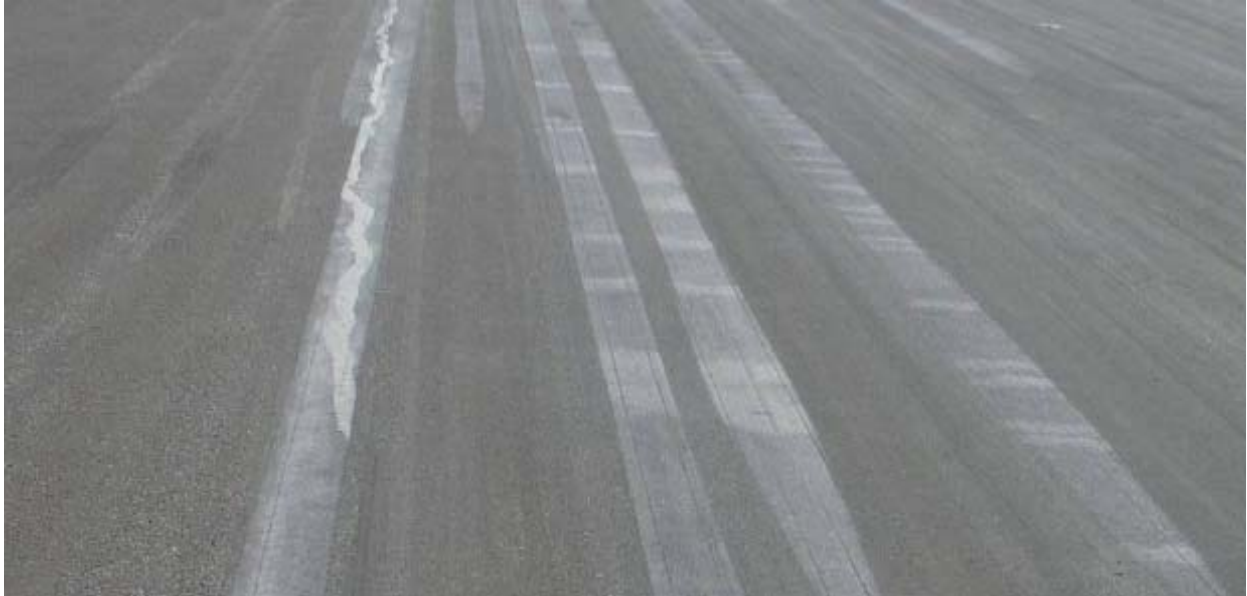
This would explain the shiny nature of the aircraft tyre tracks observed on the George runway. It could also explain the pattern in the tracks in Figures 3 and 4 as “mirrored anti-skid activity”. It could also explain why long shiny tracks appear on the runway. The theory could be that bitumen, softened or nearly melted are brought to the surface and displaced or smeared by the trafficking braking aircraft. If too much bitumen is ‘brought to the surface’ a planing situation may arise on the bitumen. Unlike aquaplaning which implies presence of water, dry planing occurs on the excess bitumen.

Figure 3 – shiny wheeltracks on George 11/29 runway

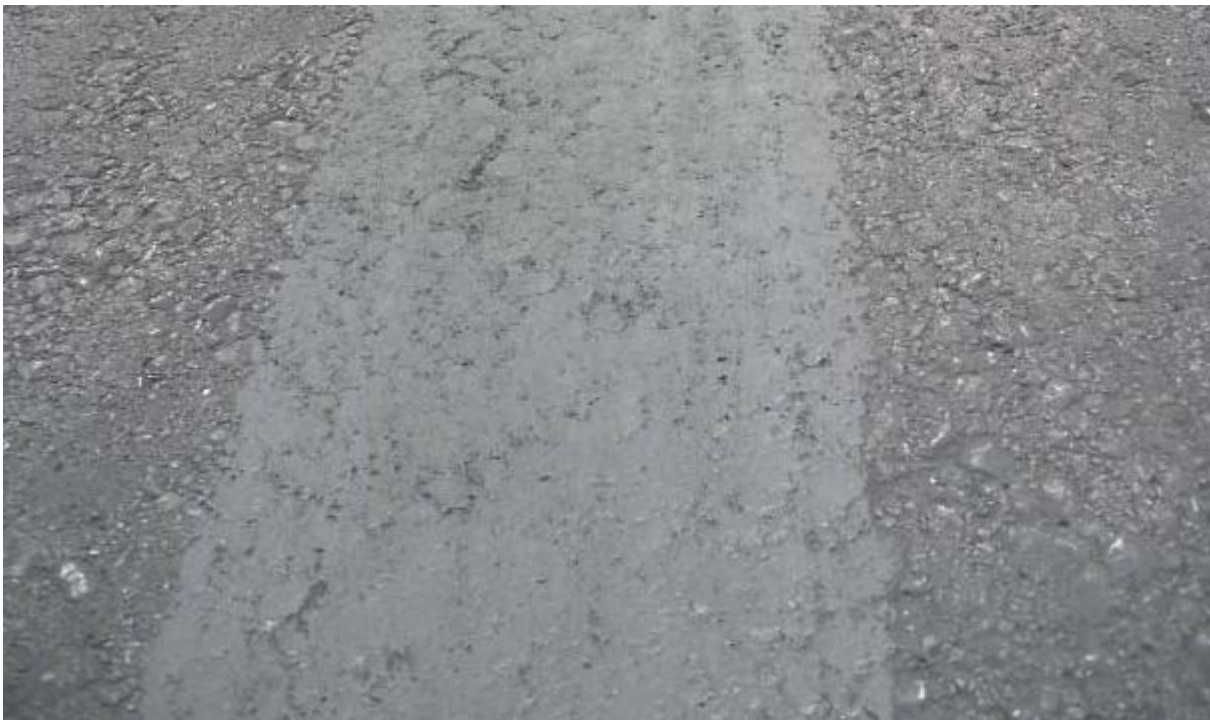
- Now there is a lubrication layer of steam and melting (or melted bitumen) which prevents the wheel spinning up. A rubber reversion aquaplaning situation is created on top of a bitu-planing situation. From observations of the runway at George more than three months after the accident, it was obvious that displacement of bitumen took place. By repeated displacement, a smoothing effect takes place that creates surfaces with less macrotecture. The bitumen being smeared by the braking aircraft causes the bitumen to in-fill the HMA voids leading to the creation of a bitumen-rich slippery surface. This can be seen in the shiny tracks on runway 11/29 (Figure 4).

Figure 4 – close up detail of shiny wheeltracks on George 11/29 runway

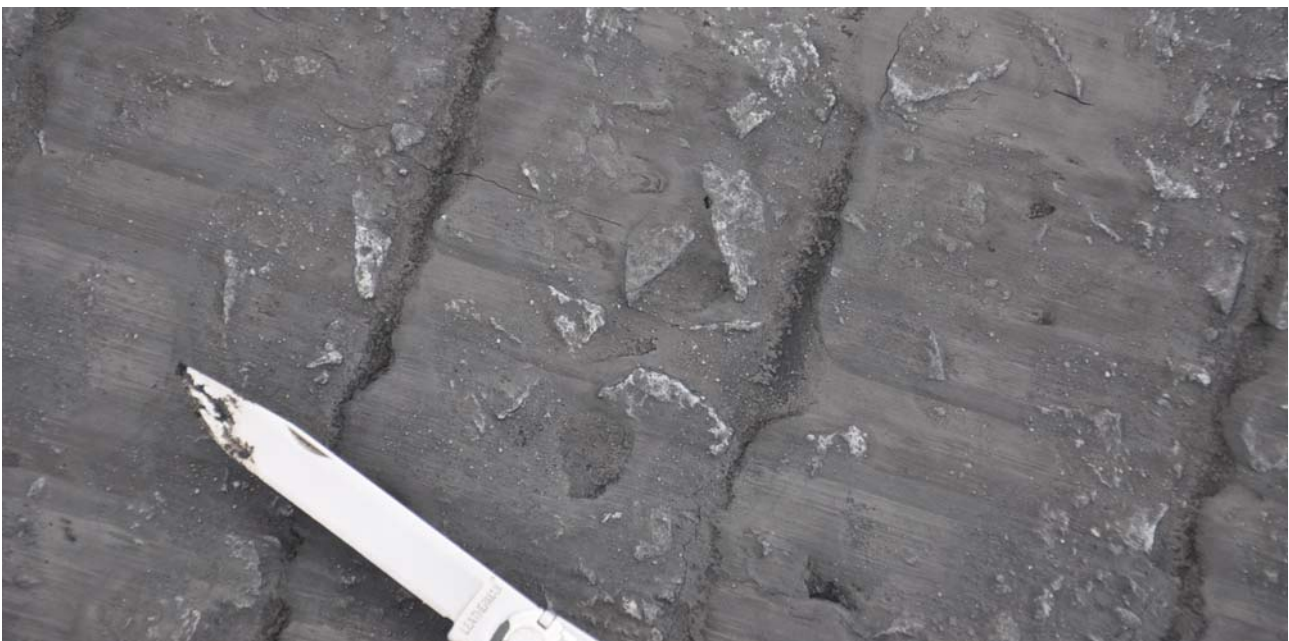
Figure 5 – close up of surface treatment rejuvenation with poor microtexture and worn inadequate grooves
