RR 419

**Investigation into premature pavement
distress at four sites in the Cape
Province**

L R Sampson, S J Emery and D Rose

Reprinted from: *Proceedings of the Annual Transportation Convention (ATC 1985)*, Pretoria, 29 July - 2 August 1985,
vol FB, paper FB7, 17 pages

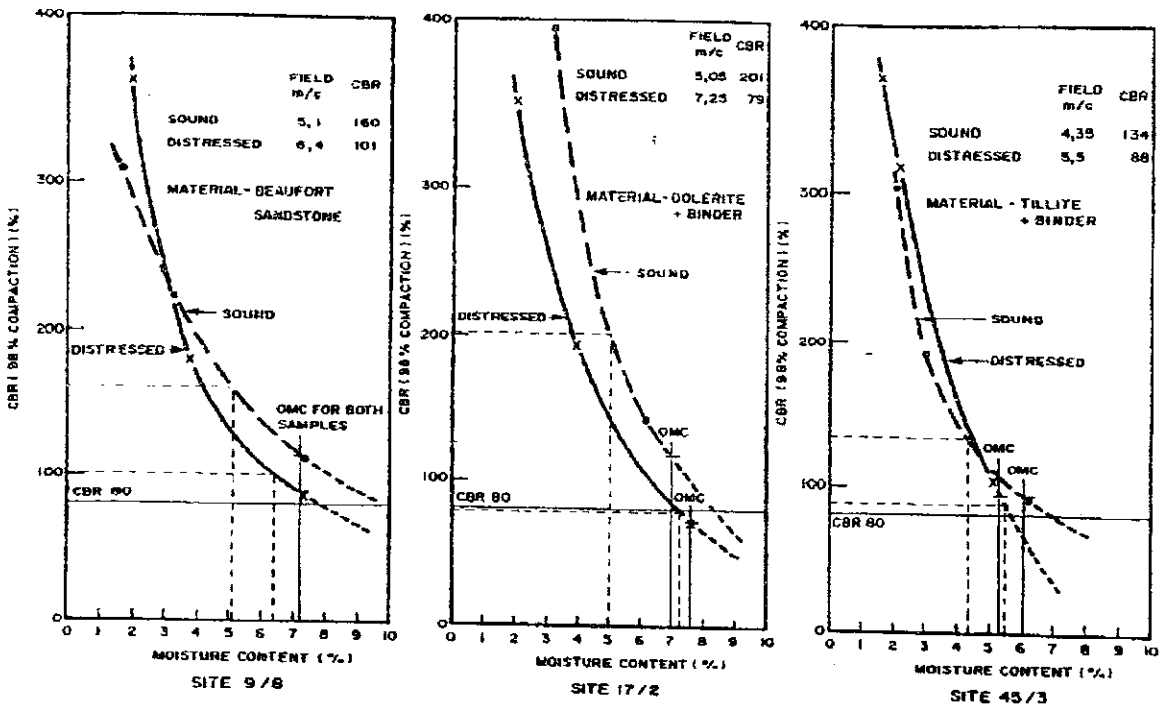
FIGURE 1 - 98% CBR VERSUS MOISTURE CONTENT RELATIONSHIP
 (all samples compacted at MOD. AASHO OMC)

In an effort to simulate the likely site compaction and moisture history of the materials, all samples were compacted at their respective Mod. AASHTO OMCs using the three compactive efforts specified by the National Institute for Transport and Road Research (NITRR, 1979 - Method A8), and the samples tested at OMC, 1/2 OMC and 1/4 OMC. The 1/2 OMC and 1/4 OMC moisture contents were obtained by drying back the samples for each compactive effort at 50 °C and equilibrating in sealed plastic bags for 48 hours. After testing, the 2,54 mm CBRs were obtained for 98 percent compaction (Table 4) and plotted against moisture content (Figure 1).

Figure 1 shows that the sound materials, which have moisture contents at the expected equilibrium (i.e. 0,62 of OMC - Table 3), give CBR values well in excess of the 80 specified at the soaked moisture contents. However, the field moisture contents at the distressed sites all give lower CBRs, with those at Sites 17/2 and 45/3 being very close to the 80 limit. The improvement in the drainage at 9/8 has reduced the moisture content and this has improved the bearing strength of the material.

It is also shown that an increase in moisture content in the distressed areas may reduce the bearing strengths to below the soaked CBR specified limit of 80. Table 4 shows that the soaked CBRs, on material from the distressed areas, are all now below 80. The completion data after construction showed that the materials gave acceptable CBRs at 98 percent Mod. AASHTO compaction, although

However, Figure 1 only serves to estimate the moisture effects on the CBR at the minimum specified compaction requirement (i.e. 98 percent of MDD). If the site densities are higher, then the in-situ CBRs are likely to be higher. Site densities at the time of this investigation ranged between 101 percent and 106 percent of Mod. AASHTO compaction and for the distressed areas were, in fact,

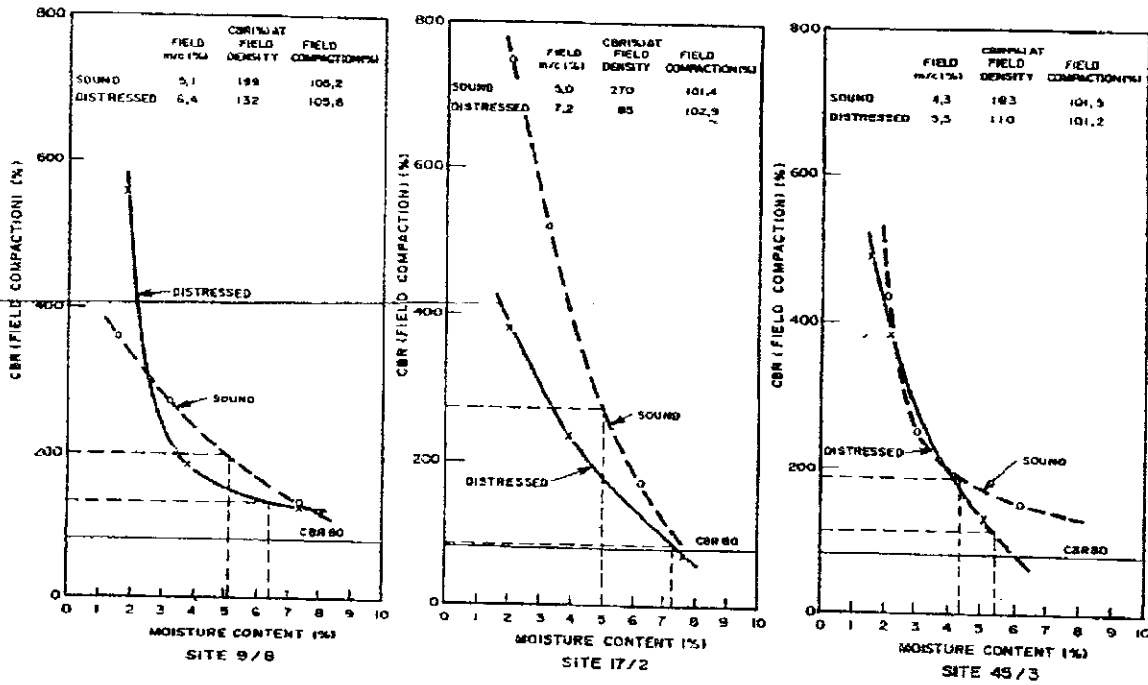
FIGURE 2 - CBR AT FIELD COMPACTION VERSUS MOISTURE CONTENT RELATIONSHIP

Figure 2 shows the CBR/moisture relationship at the field densities and Table 5 gives a comparison of the CBR results at the field moisture contents for 98 percent compaction, field compaction and from the DCP.

However, the CBR versus moisture content relationships shown in Figure 2 relate well with the actual observed performance of the materials. It is shown that at two of the sites (17/2 and 45/3) only a slight increase in moisture is required to reduce the CBR of the distressed area to unacceptable limits, even at the higher densities.

The results at 9/8 suggest that the material is acceptable, but this is probably a reflection of the densification of the layer, presumably as a result of traffic on the degraded materials. It is likely that the increase in density in the wheeltrack has caused the observed distress of rutting and crocodile cracking, especially prior to improvement of the drainage when the moisture content
